Aquifer Breach FAQ

Aquifer Breach

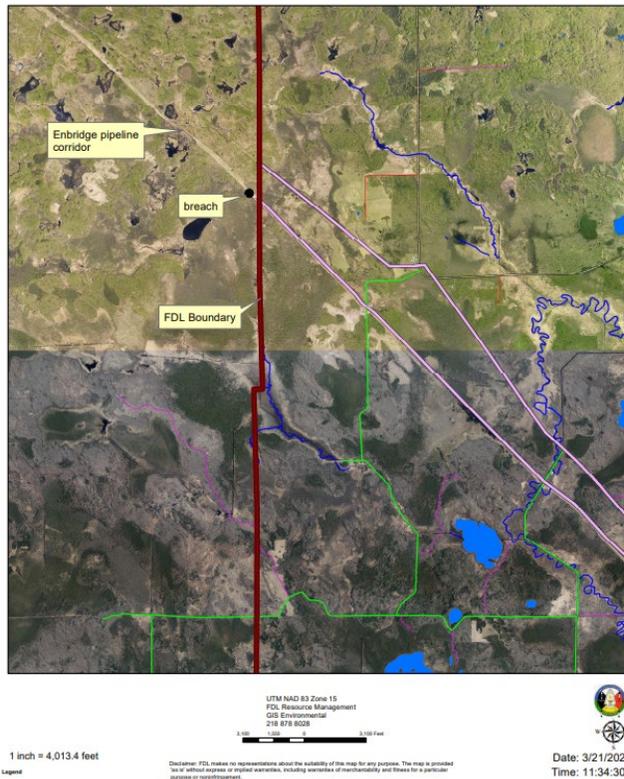
On September 10th, 2021, Fond du Lac (FDL) was notified by Enbridge of an aquifer breach that occurred at Milepost 1102.5 (see map), near the western boundary of the Reservation. The breach was rapidly discharging a high volume of water within the boundaries of the Reservation that could potentially impact the ecology of the area and the Band's natural resources. The total volume of water discharged was approximately 263,100,000 gallons. Enbridge successfully repaired the aquifer breach on April 7, 2022 and all groundwater flow onto the Reservation stopped.
